Docket No. 217 – Development and Management Plan Inspection

Northeast Utilities Service Company Certificate of Environmental Compatibility and Public Need for the construction of a 345-kV electric transmission line and reconstruction of an existing 115-kV electric transmission line between Connecticut Light and Power Company's Plumtree Substation in Bethel, through the towns of Redding, Weston, and Wilton, and to the Norwalk Substation in Norwalk, Connecticut.

Date: August 3, 2005

Location: 345kV XLPE Component

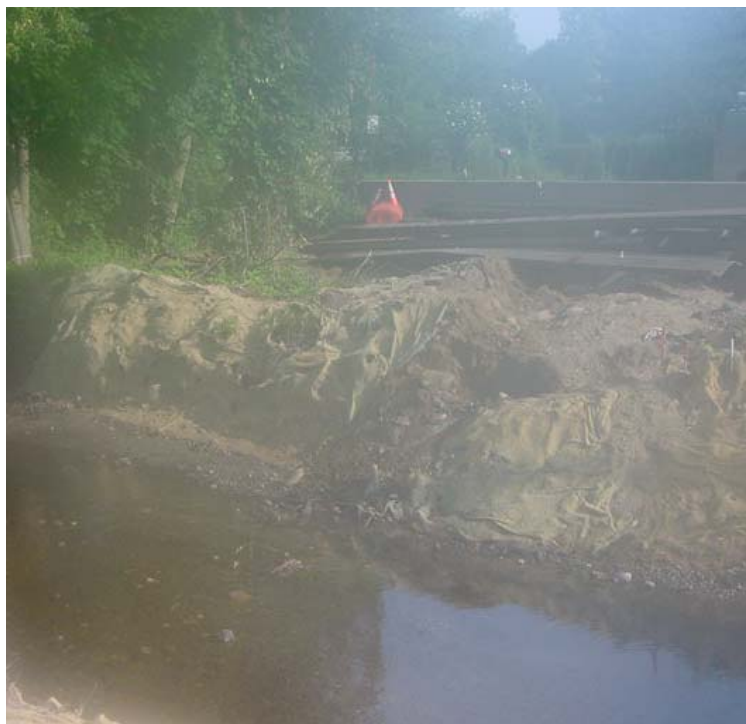
| Areas of Inspection | Observation | Recommended Action | Corrective Action |
|--|--|--|---|
| Jack and Bore | -Banks were restored with erosion control blankets but they have since slumped down along the slope. 8/3/06 | -Repair the matting ASAP and secure well. Pull back any sediment if necessary. 8/3/06 | -Needs attention |
| | - Sheeting was pulled from the receiving pit. 8/3/06 | - Restore the top of bank and slope ASAP once the sheets are removed from the area. 8/3/06 | - Needs attention when access is complete |

| Areas of Inspection | Observation | Recommended Action | Corrective Action |
|--|---|---|---|
| Inland Wetland and Watercourse encroachment and mitigation | -Sheet piling was removed from the top of bank of East Swamp Brook. The erosion control blanket here needs repair. 8/3/06 - Mats remain the base of slope at Hoyts Hill. 345kV crews will be restoring this area when access is complete. 7/5-8/3/06 | -Blankets need to be restored and secured. Restore banks further if necessary 8/3/06 -When access needs are complete, restore and allow wetland vegetation to return. All stone and gravel will have to be removed carefully and then high organic content soil should be placed here. Do not fill over the gravel. 7/5-8/3/06 | -Needs attention -N/A until access is done. This appears to be soon |

345kV XLPE: Photo on the left shows the sheet piling has been pulled from the receiving side of the stream. The erosion control matting installed last week is slumping along the bank. Photo on the right show the silt fence along the means of access to the stream needing some maintenance.

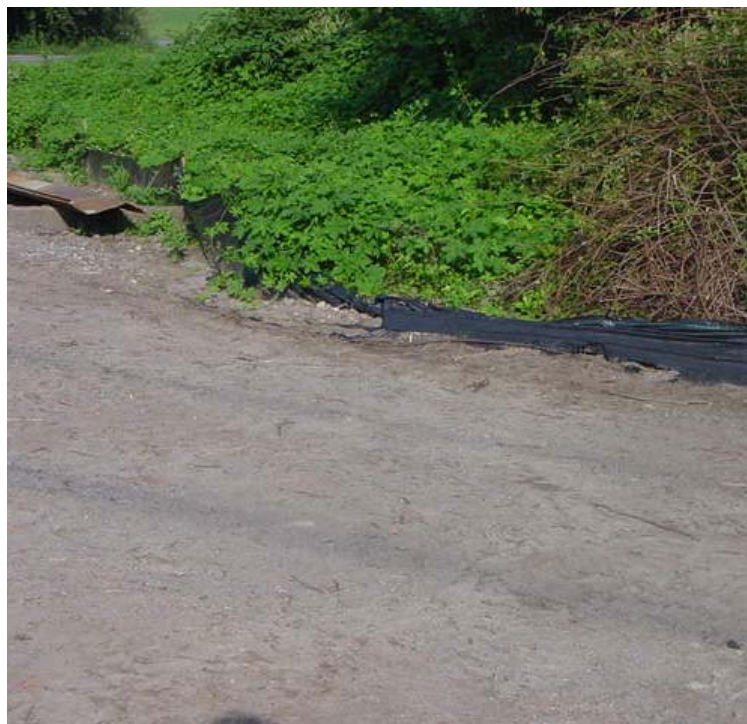
| Areas of Inspection | Observation | Recommended Action | Corrective Action |
|--|--|--|---|
| | - Minor repairs are needed to the silt fence along the ball park access 7/26-8/3/06 | - Repair as necessary. The adjacent area will be restored when work is complete. 7/26-8/3/06 | - Needs attention when feasible |

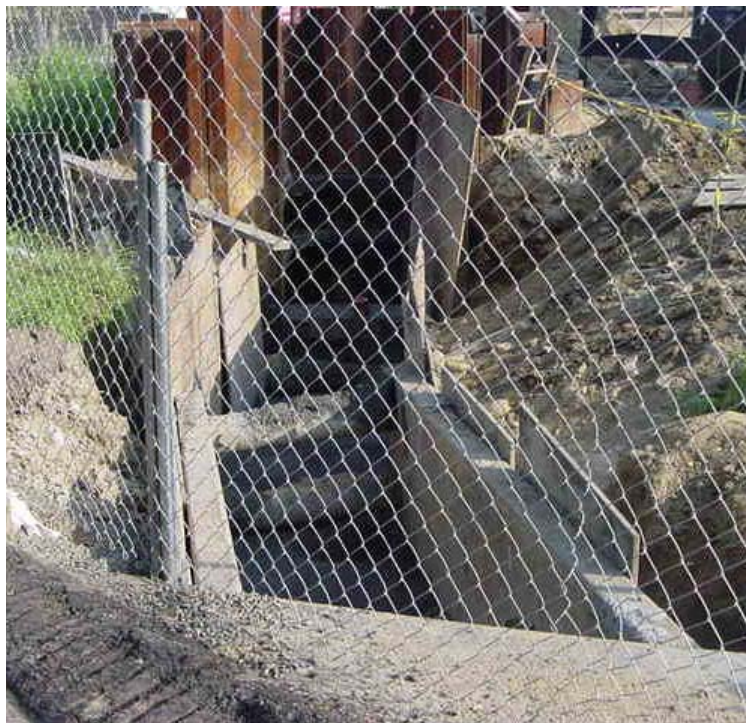
| Areas of Inspection | Observation | Recommended Action | Corrective Action |
|--|--|--|---|
| Trench and foundation construction | -The bore is complete. An open trench remains at the jack and bore pad to connect into the system. 8/3/06 | -See erosion control section for recommendations. 8/3/06 | -N/A |

Photo on the left shows an open trench remaining at the jack and bore pad to connect into the system. This area will be restored when work is complete. Photo on the right shows a stockpile

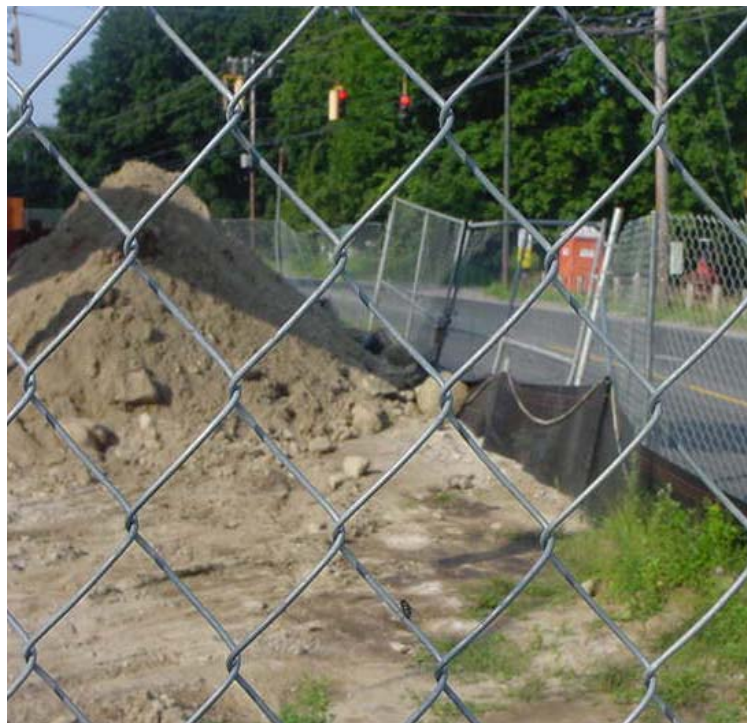
| Areas of Inspection | Observation | Recommended Action | Corrective Action |
|--|--|--|---|
| | - Stockpiles were against the silt fence at the jacking pit pad 8/3/06 | - Pull the stockpile back from the fence if feasible and make sure it does not overtop. 8/3/06 | - Needs attention when feasible |

immediately adjacent to the silt fence. Make sure this is not overtopped and pull soil back if feasible. 8/3/06
